SR 3 MP 59.52 Unnamed Tributary to Hood Canal (991612): Preliminary Hydraulic Design Report

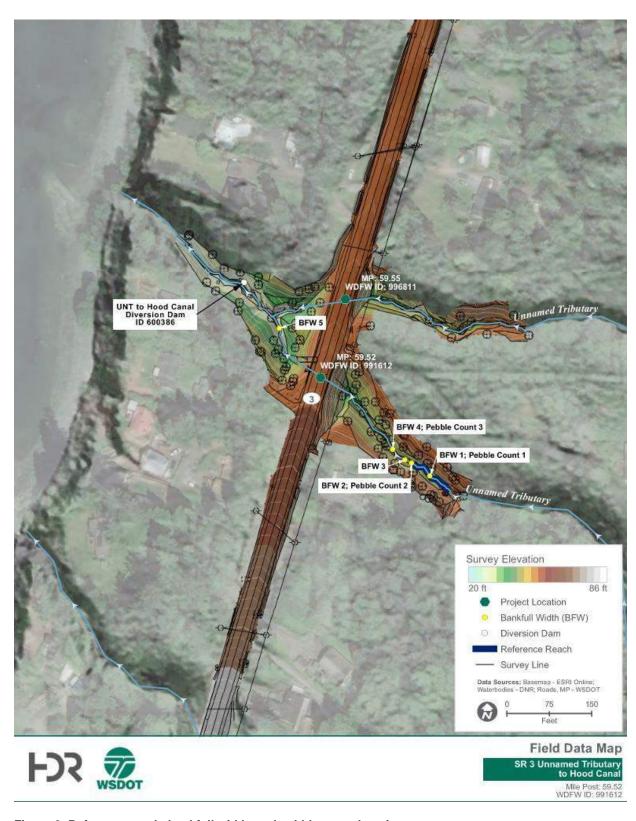
Figure 6: Reference reach, bankfull width, and pebble count locations

A reference reach approximately 50 feet long was identified approximately 200 feet upstream of the culvert inlet, as shown in Figure 6. Cross-section geometry in the reference reach was used to inform the channel design. A pebble count, BFW measurement, and valley width measurement were taken in the reference reach.

Wolman pebble counts were conducted at three locations upstream of SR 3, with approximately 150 particles sampled at each location. The pebble counts were completed next to BFWs 1, 2, and 4, shown in Figure 6 above. The pebble count at BFW 1, in the reference reach, was taken because of the similar material size observed throughout the channel. The specific pebble sediment sizes and average distribution used for design are provided in Table 5 and Figure 28, respectively. Material in the pebble counts consists primarily of sand, gravel, and cobbles as shown in Figure 29. The largest particle observed in the pebble counts was a 10.1-inch cobble. The largest particle observed during the site visit was 30-inches approximately 10 feet downstream of the culvert inlet.

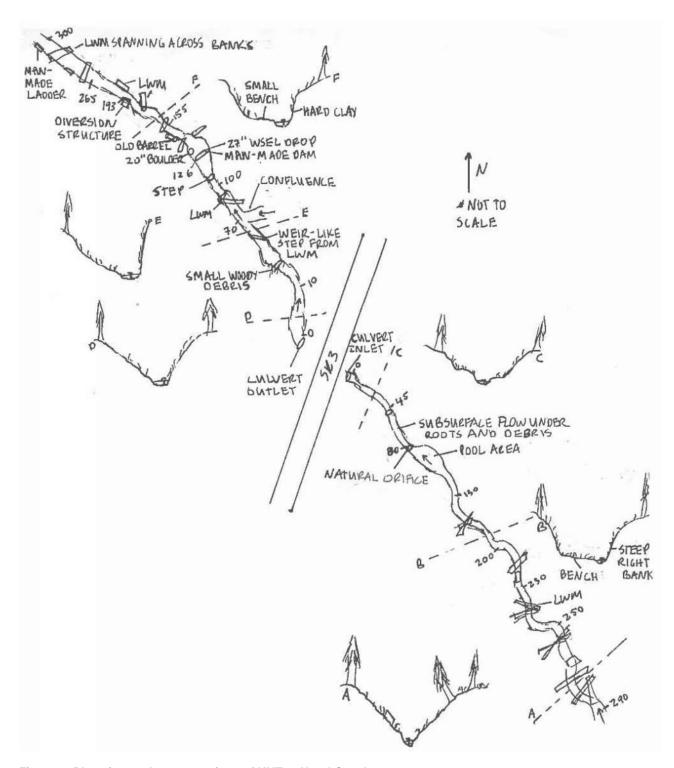
Figure 7: Plan view and cross sections of UNT to Hood Canal

The following paragraphs and figures describe field observations of UNT to Hood Canal from upstream to downstream. The existing culvert crossing is a 132-foot-long, 2-foot-diameter RCP culvert at a 6.2 percent slope. The slope of the existing culvert creates a fish passage barrier for salmonids moving upstream. The small, steep stream is potentially used by coho salmon as well as steelhead and cutthroat trout. Spawning habitat is lacking so the stream functions as a migratory corridor for juvenile fish of these species to move up into rearing habitat, particularly for overwintering before moving out into Hood Canal. The undersized culvert prevents natural stream processes including woody material and sediment transport. Figure 7 shows a field sketch of a plan view and cross sections of the UNT to Hood Canal upstream and downstream of the crossing. The stationing in the upstream reach starts at station (STA) 0 at the culvert inlet and increases from downstream to upstream. Downstream, the stationing starts at STA 0 at the culvert outlet and increases from upstream to downstream. As-builts for the crossing provided by WSDOT show the rough location and cross-sectional shape of the historical channel. The channel is not drawn in detail on the as-builts, so it was not used as a reference. No obvious signs of maintenance activity were observed.

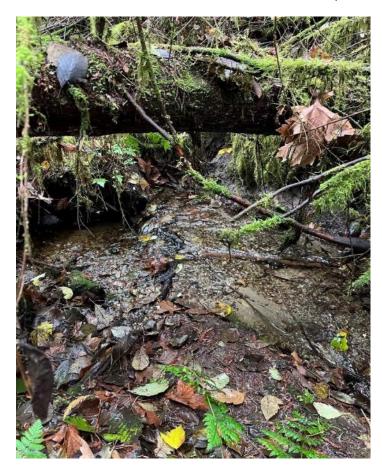
Figure 8: Typical channel characteristics at STA 290 showing small woody material looking at the right bank

The field reconnaissance survey began approximately 290 feet upstream of the culvert inlet where the channel flows under a large cedar tree's root system. From STA 290 to STA 250 the stream is a well-defined, single-threaded channel with a large amount of large woody material (LWM) present in and above the channel. The stream has a relatively straight planform, with tight bends and meanders largely influenced by LWM, and has a step-pool morphology. Riffle sections were observed between step-pool features. Smaller woody material less than 1 foot in diameter is also abundant and forms weir-like steps as depicted in Figure 8.

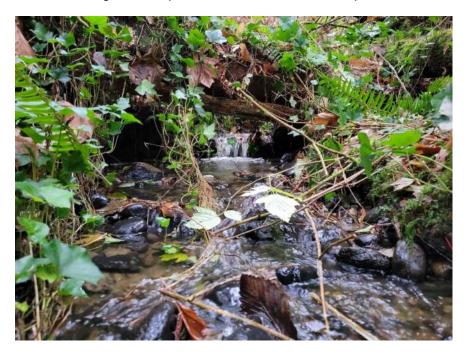
Figure 9: Typical stream characteristics downstream of STA 230 with larger material looking upstream

be the active floodplain. Downstream of STA 230 the channel maintains similar floodplain characteristics, but the bench shifts to the left bank and expands. Around STA 227 the bed material is larger than upstream with 6-inch cobbles present.

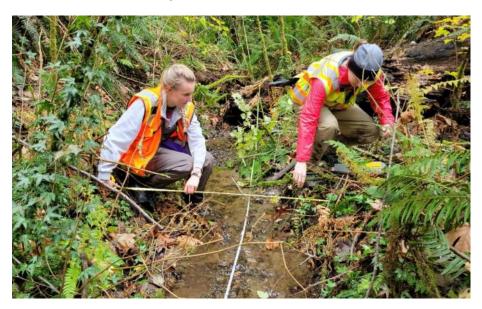
Figure 13: Stream characteristics at STA 130 and BFW 4 measurement

The fourth BFW measurement, a valley width measurement, and a pebble count were taken at STA 130 as shown in Figure 13.

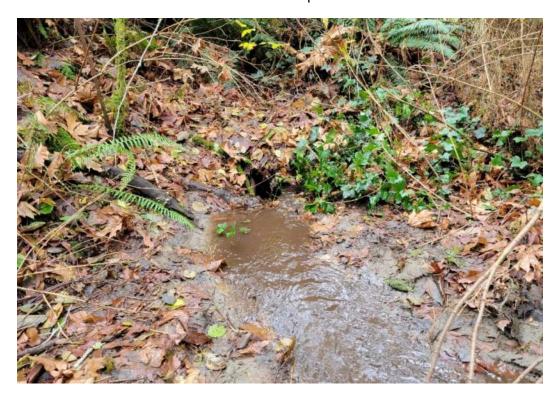
Figure 14: Looking downstream toward natural orifice where flow goes subsurface

Between STA 130 and STA 115 the stream has well defined banks, bed material consisting of sand and gravels, minimal LWM and small woody material, and small benches beyond the banks. Downstream of STA 115 the channel widens out to a pool dominated by sand deposits. This reach is different from the upstream reach because of a naturally formed orifice at STA 80 (Figure 14). This 12-by-18-inch orifice causes backwater and sediment deposits from

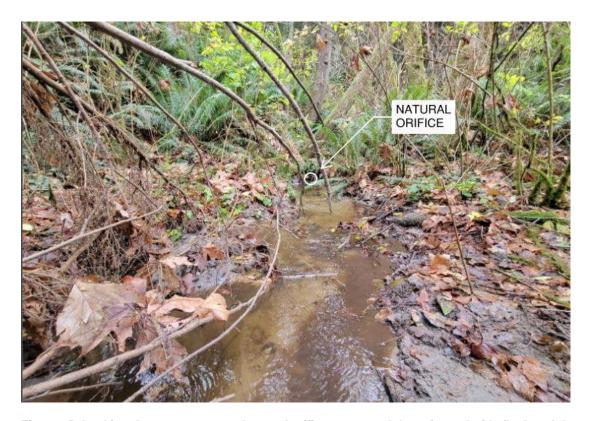
Figure 15: Looking downstream toward natural orifice; note sand deposits and wide flat bench between STA 80 and STA 115

approximately STA 103 to STA 80 as shown in Figure 15. This reach also has a wider and flatter bench than the rest of the upstream reaches, with a valley width of 22.3 feet at STA 88. The orifice causes a 3-foot water surface drop into subsurface flow under a natural bridge.

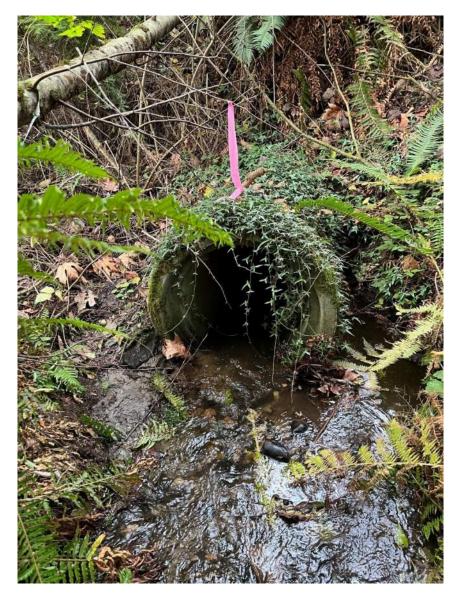
Figure 16: Looking downstream at inlet of 24-inch-diameter RCP culvert

The channel is still in open-channel conditions under accumulated roots, debris, and sediment. The channel emerges from this natural bridge and subsurface flow at STA 60. The channel flows through a large amount of LWM and then back through another natural tunnel system formed by maple roots from STA 52 to STA 45. The channel reemerges from subsurface flow at STA 45. Downstream of STA 45, the channel bed comprises cobbles and larger material than that found upstream of the orifice. Farther downstream, starting at STA 30, the channel has banks that are 1 to 3 feet high, and the substrate size increases near the culvert inlet. The culvert inlet at STA 0 is a 24-inch-diameter, RCP groove-end culvert as depicted in Figure 16. The culvert is unobstructed by sediment or debris.

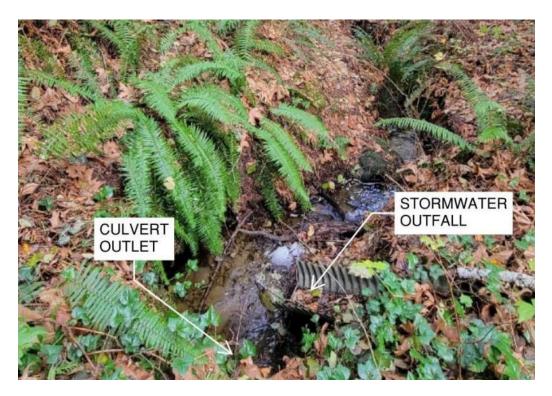
Figure 17: Culvert outlet and incised banks downstream of culvert looking downstream

Immediately downstream of the culvert outlet (Figure 17), the banks are eroded and undercut significantly. Near the culvert from approximately STA 0 to STA 45, the cross-sectional channel shape is similar to the upstream channel with a meandering thalweg, is well-defined, and is non-uniform. This portion of the downstream reach has less wood and larger bed material than the upstream reach.

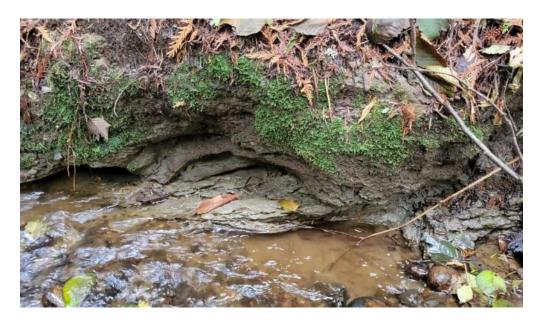
Figure 18: Patches of hardened clay in the banks and bed

The downstream channel is also a step-pool system like the upstream reach. At STA 2 on the right bank, an open corrugated metal storm drain outlets into the channel from the steep slope from SR 3. The banks are incised approximately 3 to 4 feet at the culvert outlet and have steeply sloping valley walls. The largest material observed on site, a 30-inch boulder, is present at STA 11. Between STA 19 and STA 35, small woody material causes several weir-like step drops. The roughness in the floodplain is lower from STA 0 to STA 25, but downstream of STA 25 the tree and vegetation density increases to be similar to the upstream reach. Throughout the downstream reach, the bed and banks have patches of hardened clay starting at STA 44 (Figure 18).

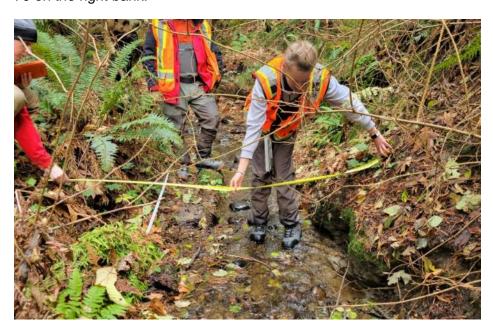
Figure 19: Stream characteristics at STA 53 and BFW 5 measurement

Starting near STA 44, the bed material transitions to sand, gravel, and small to large cobbles, smaller material compared to the reach between the culvert outlet and STA 44. Near STA 44, the channel becomes more uniform, U-shaped, has higher banks, and has a less accessible floodplain compared to the channel near the culvert outlet. A large pool was observed upstream of a naturally formed log weir at STA 44, with a water surface drop of approximately 6 inches. Downstream of the drop, the fifth and final BFW measurement of 6.5 feet and a valley width measurement of 13.75 feet were taken at STA 53. Downstream of BFW 5 (Figure 19), the confluence (Figure 20) with another UNT to Hood Canal from WDFW ID 996811 occurs at STA 70 on the right bank.

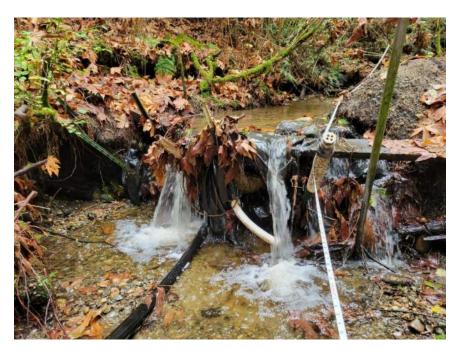
Figure 21: Looking upstream at constructed diversion dam with aggraded channel material upstream

Downstream of the confluence, from STA 70 to the downstream extents of the UNT to Hood Canal at STA 450, the LWM is larger than that found upstream and more dramatically directs and influences the course of the stream. The larger LWM lines the banks and spans the channel. In the section between STA 70 and STA 120 the bed material gets finer and transitions to sand and gravel as the channel transitions to a pool. The pool is formed from an old, constructed dam at STA 126 (Figure 21) that creates a 27-inch drop from the water surface at the dam to the water surface immediately downstream. The dam has aggraded streambed material up to the crest of the structure.

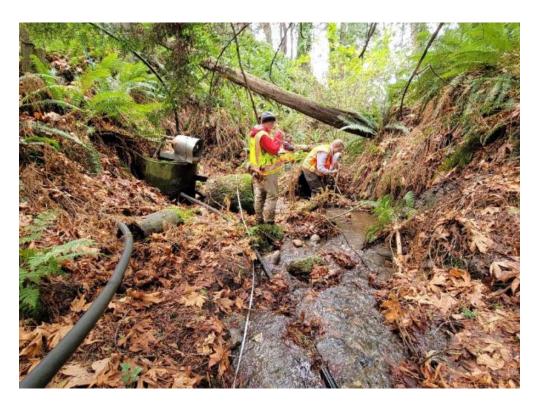
Figure 22: Diversion structure (photo looking downstream)

Downstream of the structure, streambed materials coarsen to cobbles and small boulders, LWM is abundant, and banks are more undercut. From STA 155 to STA 176 the right bank is made of hard clay. From STA 155 to STA 195 the channel has banks approximately 1 foot high and the thalweg meanders because of abundant LWM. An operating diversion structure at STA 195 on the left bank (Figure 22) is connected to the constructed dam at STA 126 by a black pipeline lying in the stream. Starting at STA 231, the stream becomes more channelized, has boulders that cause step-like drops, and contains abundant LWM that influences the path of flow like shown in Figure 23. LWM present at STA 267 results in a large backwater pool. A constructed step ladder present at STA 300 on the right bank leads to a walking path on the terrace above the channel. Detailed site reconnaissance notes were stopped at this point.

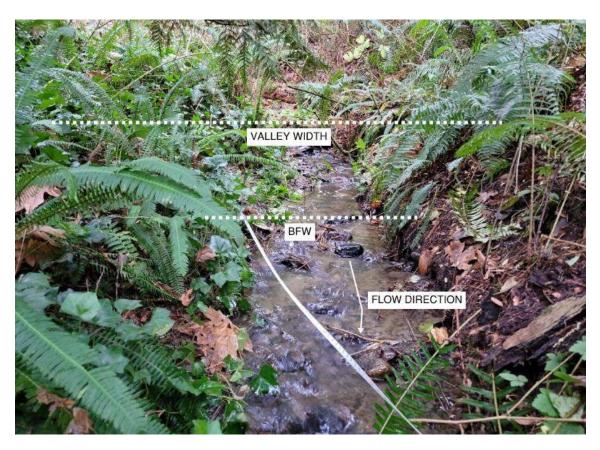
Figure 25: Reference reach, looking upstream

A pebble count and BFW measurement (BFW 1) were collected within the reference reach. The material observed consisted primarily of sand, gravel, and cobbles. BFW measurements are presented in Section 2.7.2 and streambed sediment observations are discussed in Section 2.7.3. The location of the reference reach and BFW measurement locations are shown in Figure 6 in Section 2.6.2 above. This reference reach was used to inform the design of the proposed channel shape.

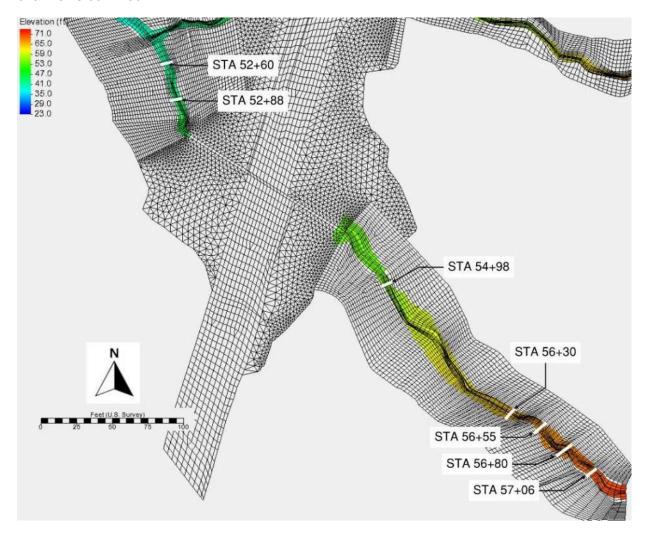
Figure 27: FUR locations

The floodplain utilization ratio (FUR) is determined by dividing the flood-prone width (FPW) by the BFW. A ratio under 3.0 is considered a confined channel, and a ratio above 3.0 is considered an unconfined channel. The FPW was determined from the modeled 100-year event width for existing conditions. The cross sections chosen to analyze the FUR are outside of the influence from the confluence, the culvert outlet, and backwater from subsurface flow and the culvert inlet. Seven cross sections spaced approximately 25 feet apart from each other, outside of backwater influences, were chosen to measure the FPW as depicted in Figure 27. These values were each divided by the design BFW of 5.3 feet to compute the FUR. Table 4 shows each FPW, the calculated FUR, and the average FUR across all cross sections. The upstream FUR is 1.6 and the downstream FUR is 1.2. The average result is a FUR of 1.5; therefore, the channel is confined.

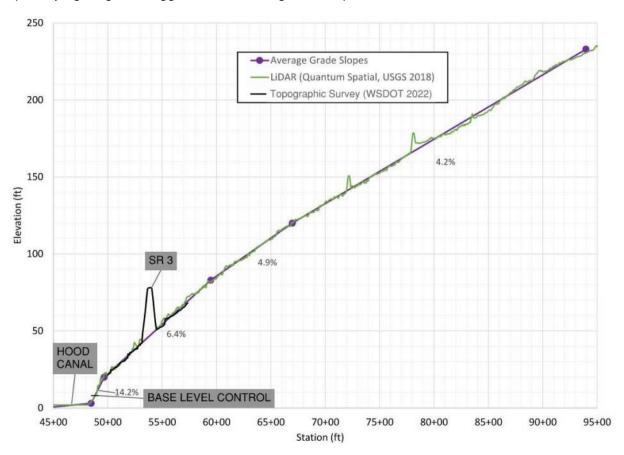
Figure 30: Watershed-scale longitudinal profile

On a large-scale, the long profile shows similar gradients upstream and downstream of the crossing with no vertical separation, indicating a low likelihood for a headcut to propagate upstream. If the downstream diversion structure is removed, there is potential for the stream's vertical profile to adjust through the project area. Additional information on how the channel bed characteristics affect degradation will be provided in the Geotechnical Memorandum. Details of a draft geotechnical report with a boring hole completed on May 16 and 17, 2022 are included in section 7.

A projected equilibrium slope in section 7.2 indicates that the channel could degrade up to 7 feet, but the hardened clay deposits in the downstream reach may make the channel more resistant to vertical bed adjustments. See Section 7.2 for a more specific discussion of quantifying long-term aggradation and degradation potential.

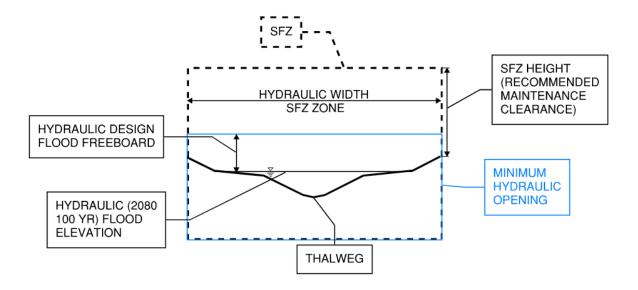
Figure 34: Minimum hydraulic opening illustration for UNT to Hood Canal SR 3 MP 59.52

The minimum hydraulic opening is defined horizontally by the hydraulic width and the total height is determined by vertical clearance and scour elevation. This section describes the minimum hydraulic width and vertical clearance; for discussion on the scour elevation see Section 7. See Figure 34 for an illustration of the minimum hydraulic opening, hydraulic width, freeboard, maintenance clearance terminology, and structure-free zone (SFZ) recommendation.

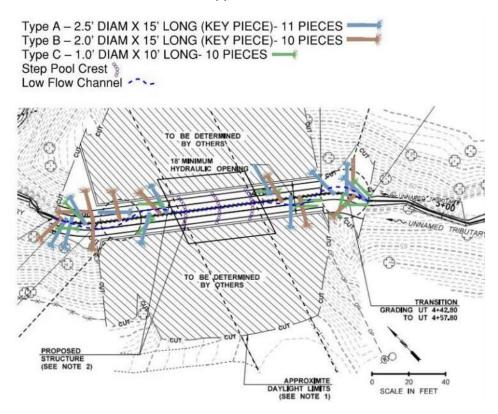
Figure 35: Conceptual layout of habitat complexity for a bridge design

time, mobility for LWM is not determined and will be assessed for the Final Hydraulic Design (FHD). Anchoring is anticipated until stability calculations are completed. Within the structure, channel-spanning step pool crests will be used to promote channel complexity. LWM calculations are referenced in Appendix F.

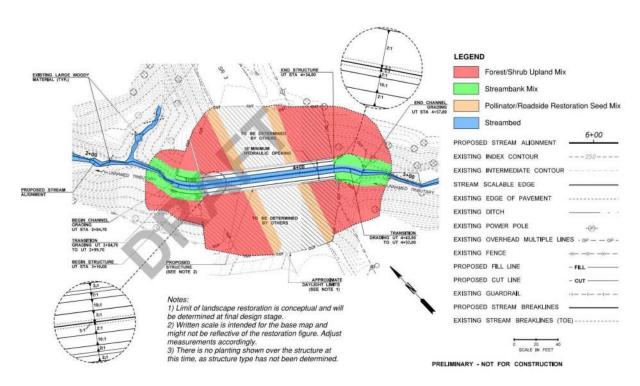
Figure 37: Conceptual restoration plan

- Pollinator/Roadside Restoration Seed Mix Promotes pollinators and provides erosion control benefits with species acclimated to exposed conditions and low fertile soils. This is generally applied to the first 10 feet from the edge of pavement or to the extent that matches the landscape characteristics (e.g., roadside swale area) for maintenance purposes. This zone will transition to the upland mix, which includes native trees, shrubs, and groundcovers.

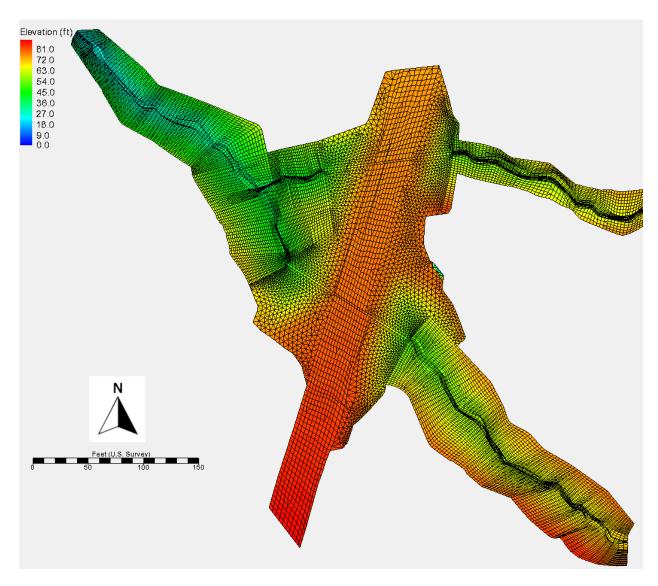
Figure 38: Existing-conditions computational mesh with underlying terrain

The hydraulic model upstream and downstream extents start and end within the survey data. With a very confined system, LiDAR is not needed to supplement the topographic survey because the detailed survey data provides enough area to adequately model the flow without the water surface touching the edge of the domain. Measured along the channel centerline, the model boundary starts approximately 280 feet upstream of the existing culvert inlet and ends approximately 300 feet downstream of the existing culvert outlet at MP 59.52 (WDFW ID 991612). The computational mesh elements are a combination of patched (quadrilateral) and paved (triangular) elements, with finer resolution in the channel and larger elements in the floodplain. The existing mesh covers a total area of 82,123 square feet (SF) or 1.9 acres, with 12,873 quadrilateral and 5,024 triangular elements (Figure 38). The proposed mesh covers a total area of 79,638 SF, with 13,028 quadrilateral and 8,225 triangular elements (Figure 39).

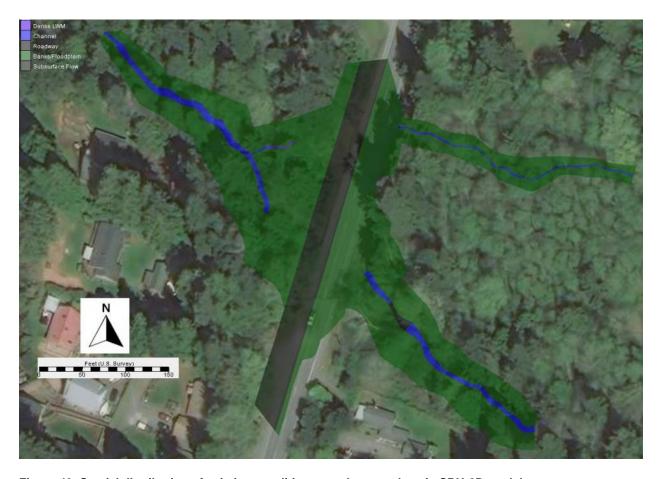
Figure 40: Spatial distribution of existing-conditions roughness values in SRH-2D model

Material	Manning's n
Dense LWM	0.20
Channel	0.11
Roadway	0.02
Banks/floodplain	0.17
Subsurface flow	0.17

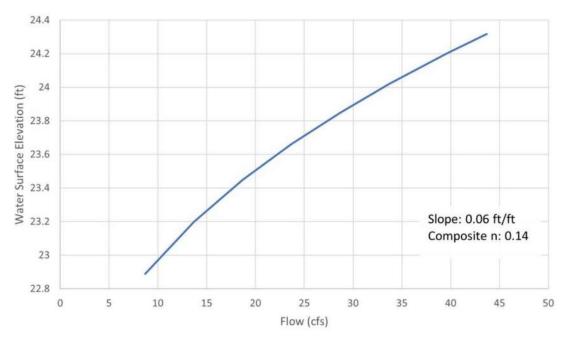
Figure 44: Downstream outflow boundary condition normal depth rating curve

Model simulations were performed using constant discharges for the 2-year, 100-year, 2080 projected 100-year, and 500-year peak discharges summarized in Section 3. For the culvert at WDFW 991612 flows of 6.9, 24.0, 34.6 and 31.5 cfs were used at the 2, 100, 2080 100-year and 500-year discharges respectively. For the culvert at WDFW 996811 flows of 1.8, 6.3, 9.1 and 8.2 cfs were used at the 2, 100, 2080 100-year and 500-year discharges respectively. External boundary conditions were applied at the upstream and downstream extents of the model domain and remained the same between the existing- and proposed-conditions runs. The two culverts in the model had separate HY-8 inputs as depicted in Figure 42(WDFW ID 991912) and Figure 43 (WDFW ID 996811). Two constant flow rates were specified at the upstream external boundary conditions (one for each of the two UNTs to Hood Canal), while one normal depth rating curve was specified at the downstream boundary (Figure 44). A sensitivity analysis was done with the rating curve to determine that the downstream boundary condition will not affect the hydraulic results at the crossing. The downstream normal depth boundary condition rating curve was developed within SMS using the existing terrain, assuming a downstream slope of 6.0 percent based on topographic survey data. The rating curve also assumed a composite roughness of 0.14. Model simulations were run for a sufficiently long duration until the results stabilized across the model domain. Existing boundary conditions are depicted in Figure 45 and proposed boundary conditions are depicted in Figure 46.

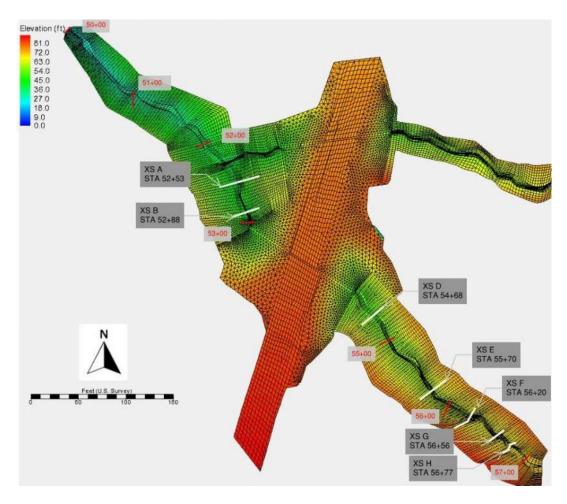
Figure 47: Locations of cross sections used for results reporting

In the cross section upstream of the culvert backwater, average main channel velocities range from 1.6 feet per second (ft/s) during the 2-year event to 3.6 ft/s at the 500-year event. In the downstream reaches the average channel velocities range from 2.1 ft/s during the 2-year event to 4.0 ft/s during the 500-year event. Shear values in the upstream reach range from 0.3 pounds per square foot (lb/SF) during the 500-year event to 4.1 lb/SF during the 500-year event. Shear values on the downstream range from 2.0 lb/SF at the 2-year event to 5.2 lb/SF during the 500year event. Some of the highest velocities and shear stress values occur at the station downstream of the culvert outlet (STA 52+88) during the 500-year event: a velocity of 4.0 ft/s and a shear stress of 5.2 lb/SF. The highest velocity and shear values are 5.8 ft/s at the drop structure 130 feet downstream of the culvert outlet and 14.9 lb/SF at the drop to subsurface flow 80 feet upstream of the culvert inlet. At the culvert outlet the velocity at the 500-year event is 4.0 ft/s with a shear stress of 9.4 lb/SF. Upstream the depths range from 0.8 foot during the 2-year event to 3.7 feet during the 500-year event. Depths in the downstream reach range from 0.8 foot at the 2-year event to 2.1 feet during the 500-year event. A plan view of the 100-year velocity magnitudes is depicted in Figure 50 and floodplain and main channel velocities are also summarized in Table 14.

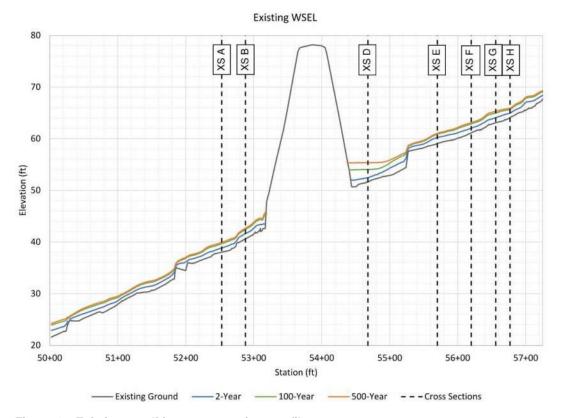
Figure 48: Existing-conditions water surface profiles

Main channel extents were approximated by 2-year event water surface top widths.

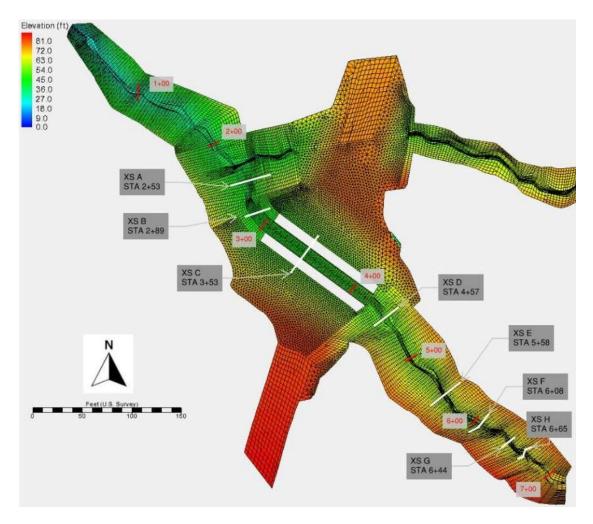
Figure 51: Locations of cross sections on proposed alignment used for results reporting

When comparing velocities and shear stresses throughout the reach, the velocities vary as much as 1 ft/s from upstream to downstream and the shear stresses vary as much as 2 lb/SF. Refer to Figure 51 for the alignment used for reporting proposed results and cross-section locations and stations. The longitudinal stationing varies in existing versus proposed, but the location of each cross section, denoted by letters, is the same between existing and proposed. See appendix H for detailed results for velocities, water surface elevations, depths, and shear values for each flow event. A longitudinal profile is shown in Figure 52, and a typical section through the structure is depicted in Figure 53. Proposed-conditions 100-year velocities are depicted in Figure 54. Average floodplain and main channel velocities are summarized in Table 16.

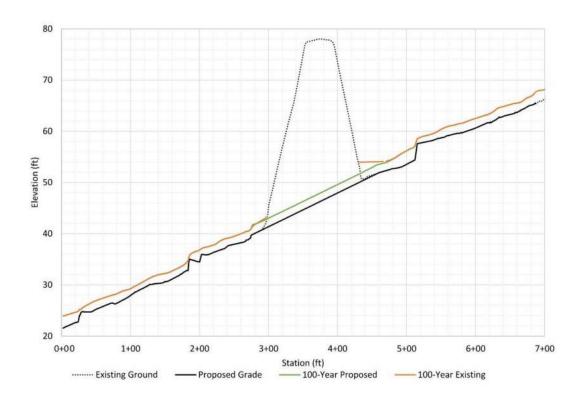
Figure 55: Existing- and proposed-conditions 100-year water surface profile comparison along proposed alignment

A flood risk assessment will be developed during later stages of the design. The risk to infrastructure downstream of the crossing is low as the model shows that no changes occur downstream of the immediate vicinity of the culvert outlet.

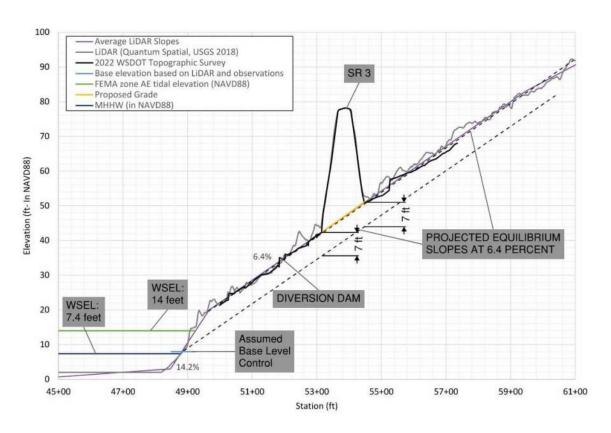
Figure 57: Potential long-term degradation at the proposed structure

Additional equilibrium slopes were calculated using the Shields' and Meyer-Peter Muller equations (FHA 2012b); however, each of these resulted in equilibrium slopes of less than 1 percent and were deemed to not be applicable at this site.

Long-term degradation is expected to range from 0 to 7 feet. No large grade breaks or slope discontinuities exist in the immediate vicinity of the project. Refer to section 7.2 for a more detailed discussion of long-term degradation and aggradation.

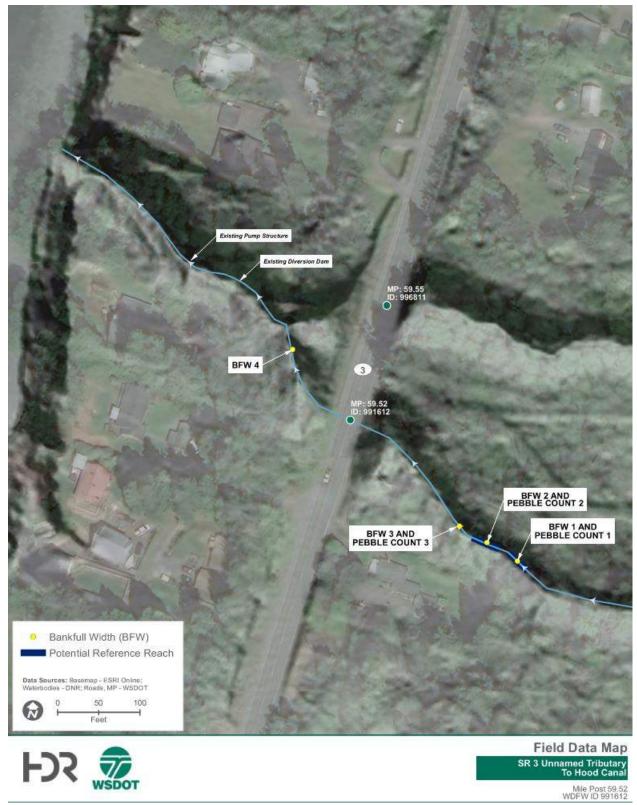
Figure 1: Reference reach, BFW, and pebble count locations

Tuble 1. Burnyan Width Media and There's site recommunistance visit					
BFW #	BFW	Valley Width	Distance from	Included in Design	Concurrence Notes
		(ft)	culvert (ft)	Average	
1	4.5	20.0	212 (Upstream)	Yes	See Table 3
2	4.8	18.5	174 (Upstream)	Yes	See Table 3
3	6.0	18.8	130 (Upstream)	Yes	See Table 3
4	6.5	13.8	53 (Downstream)	Yes	See Table 3
Design Average	5.4	17.8			See Table 3

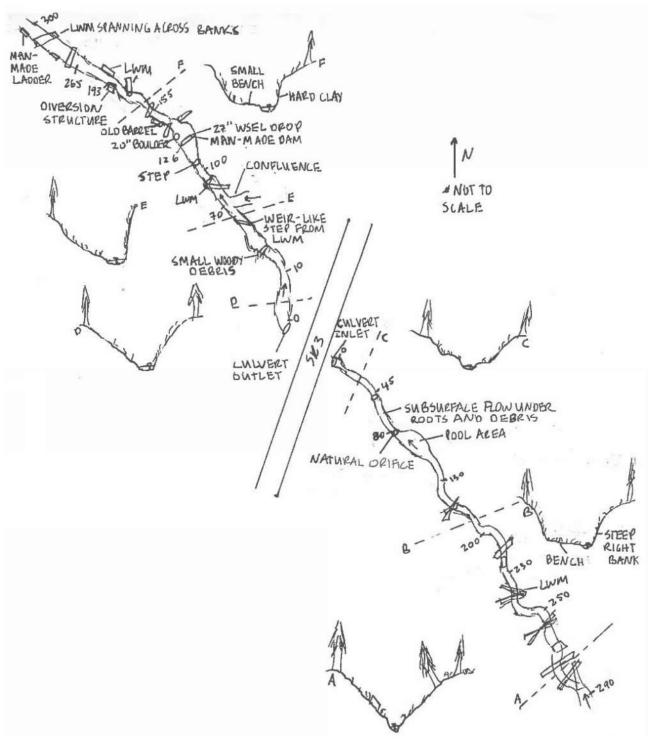
Figure 2: Plan view and cross sections of UNT to Hood Canal

The following paragraphs and figures describe field observations of UNT to Hood Canal from upstream to downstream. Figure 2 shows a field sketch of a plan view and cross sections of the UNT to Hood Canal upstream and downstream of the crossing. The stationing in the upstream (US) reach starts at station (STA) 0 at the culvert inlet and increases from downstream to upstream. Downstream (DS), the stationing starts at 0 at the culvert outlet and increases heading downstream.

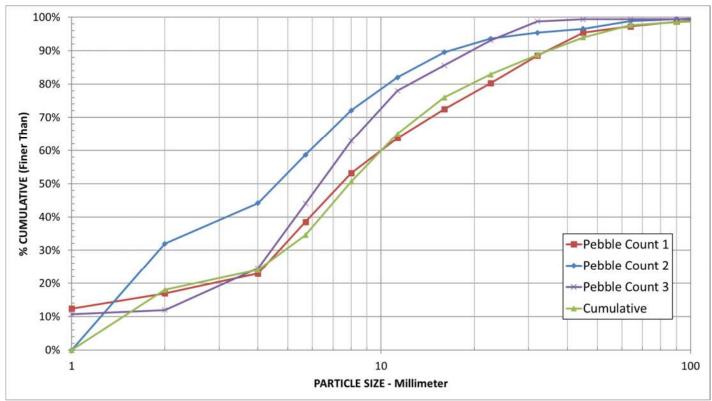
Figure 3: Sediment size distribution

Wolman pebble counts were conducted at three locations upstream of SR 3, with approximately 150 particles sampled at each location. The two most upstream pebble counts were completed in the upstream potential reference reaches, shown in Figure 1 above. The pebble count at BFW #1 in the first potential reference reach was taken because of the similar material size observed throughout the channel. The cumulative distribution and specific pebble sediment sizes are provided in Figure 3 and Table 2. Material primarily consisted of sand, gravel and small cobbles as shown in Figure 4.
